SITE: IDEAL COOPERAGE
DATE: MAY 7-9, 1991
PHOTOS BY: P. DI PASCA (TAT)
DESCRIPTION: FIRST WEEK OF
SITE ACTIVITY

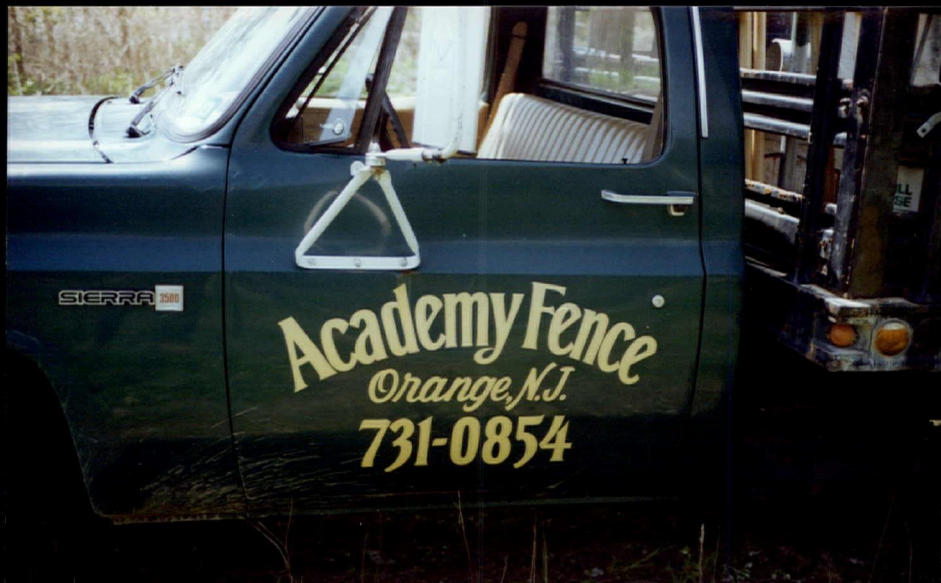
SITE: Ideal Cooperage, Jersey City, NJ
DATE: 05/08/91 PHOTO BY: P. Di Pasca
DESCRIPTION: Name, address and phone
number of fence
contractor

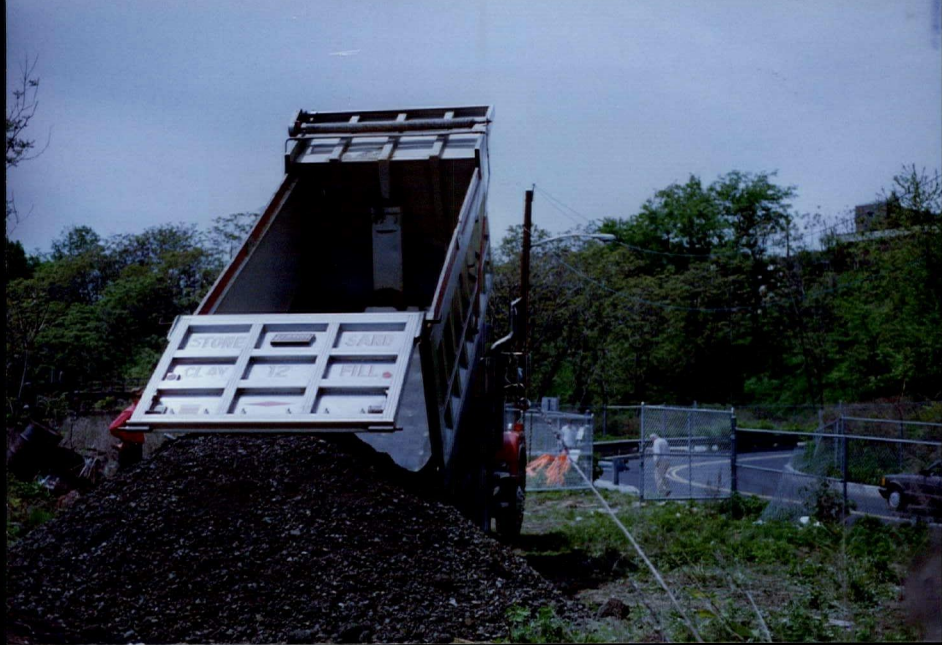
SITE: Ideal Cooperage, Jersey City, NJ
DATE: 05/08/91 PHOTO BY: P. Di Pasca
DESCRIPTION: Delivery of road stone for
entrance to site
(1st load)

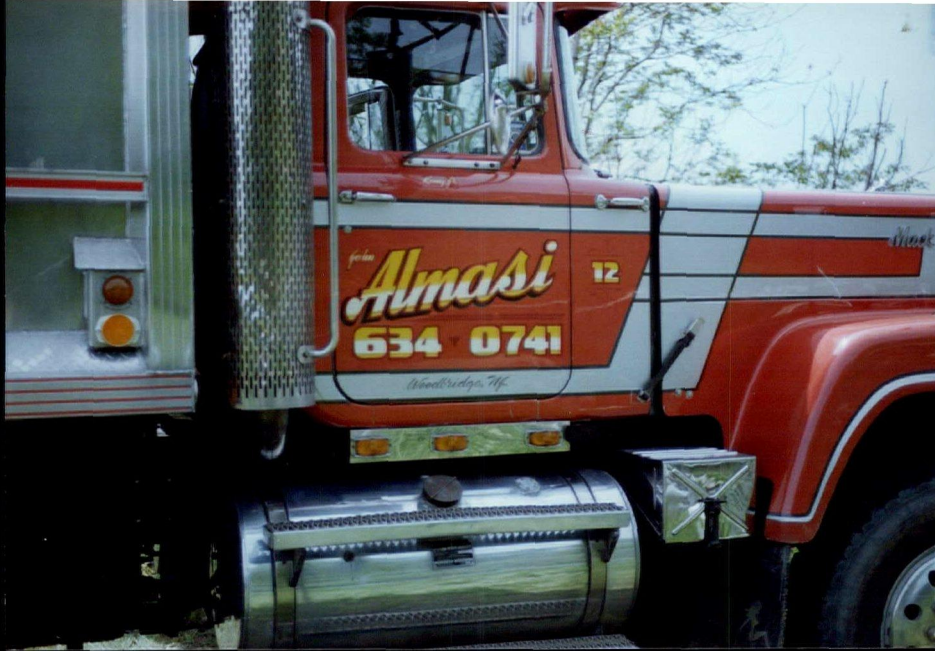
SITE: Ideal Cooperage, Jersey City, NJ
DATE: 05/08/91 PHOTO BY: P. Di Pasca
DESCRIPTION: Name, address and phone number
of road stone supplier

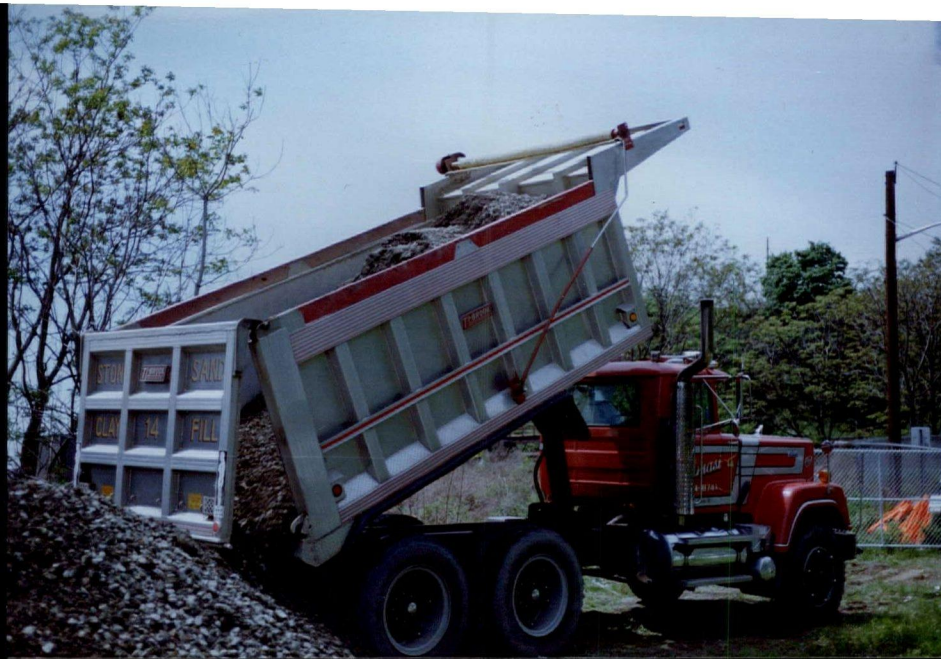
SITE: Ideal Cooperage, Jersey City, NJ
DATE: 05/08/91 PHOTO BY: P. Di Pasca
DESCRIPTION: Delivery of road stone for
entrance to site
(2nd load)

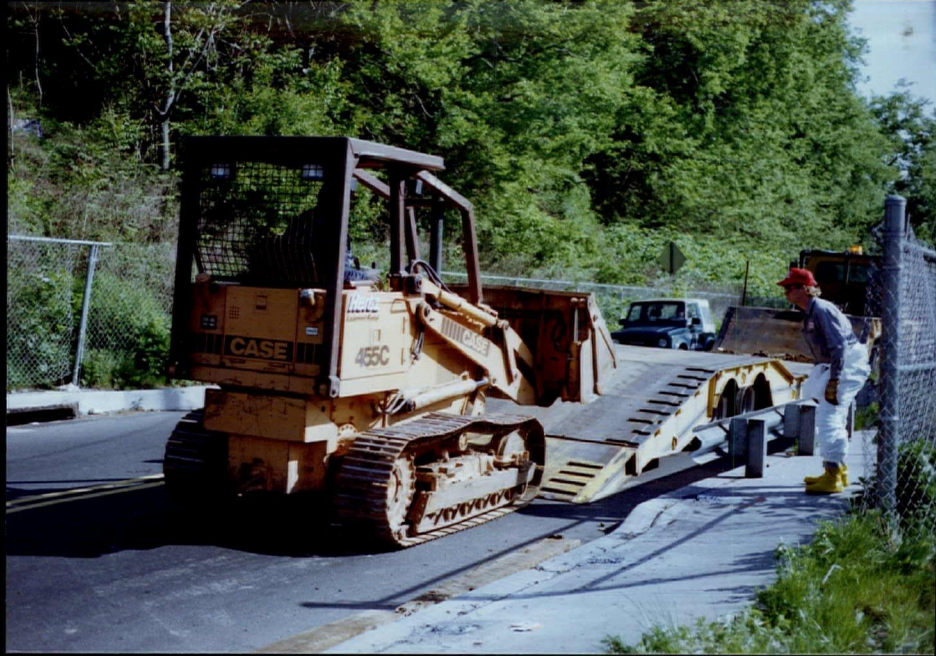
SITE: Ideal Cooperage, Jersey City, NJ
DATE: 05/08/91 PHOTO BY: P. Di Pasca
DESCRIPTION: Delivery of track loader

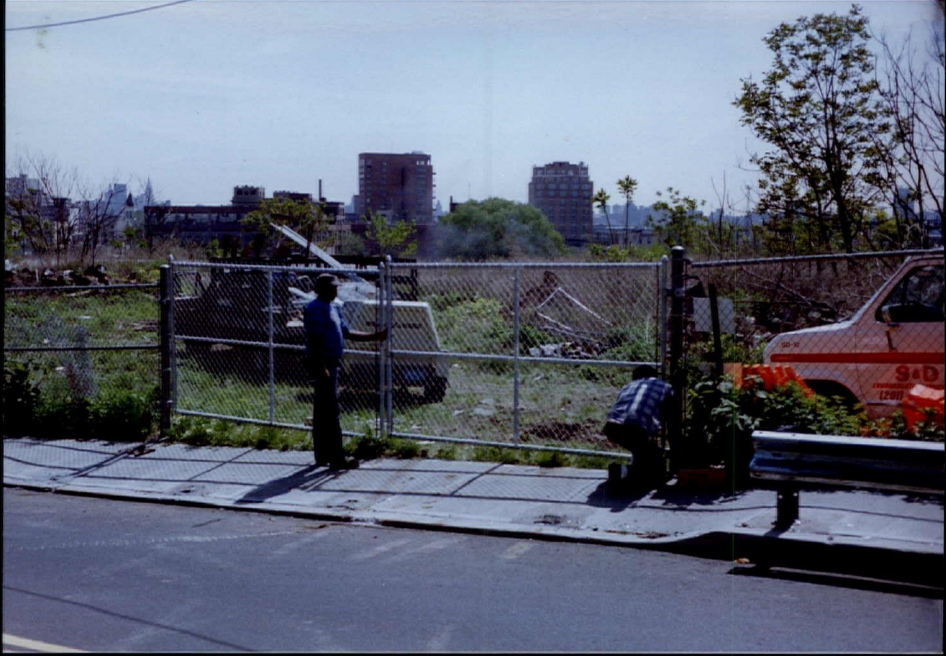
SITE: Ideal Cooperage, Jersey City, NJ
DATE: 05/08/91 PHOTO BY: P. Di Pasca
DESCRIPTION: Installation of new
front gate

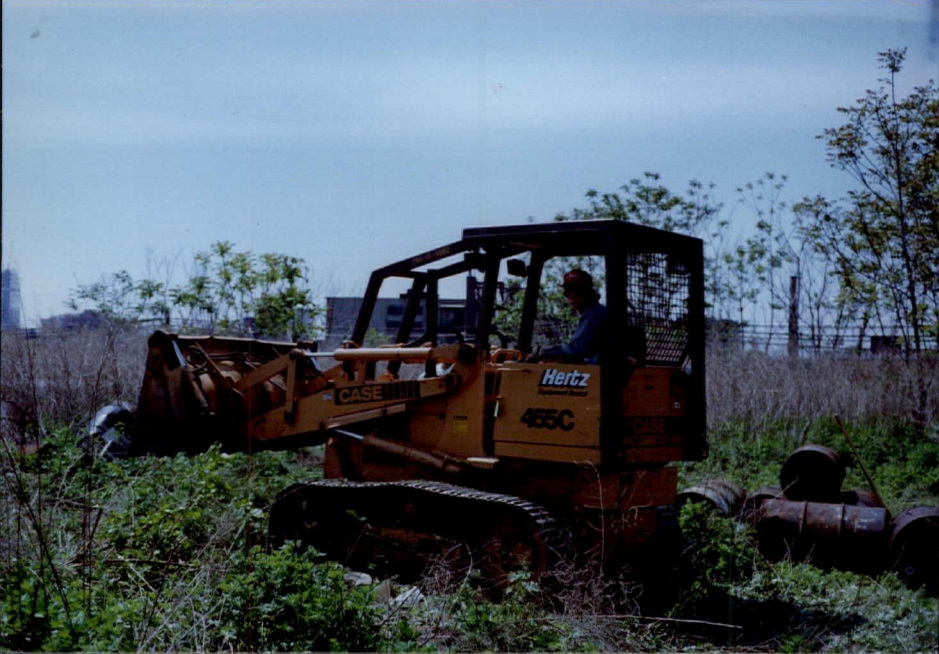
SITE: Ideal Cooperage, Jersey City, NJ
DATE: 05/08/91 PHOTO BY: P. Di Pasca
DESCRIPTION: Track loader used for
clearing of debris and drum
restaging

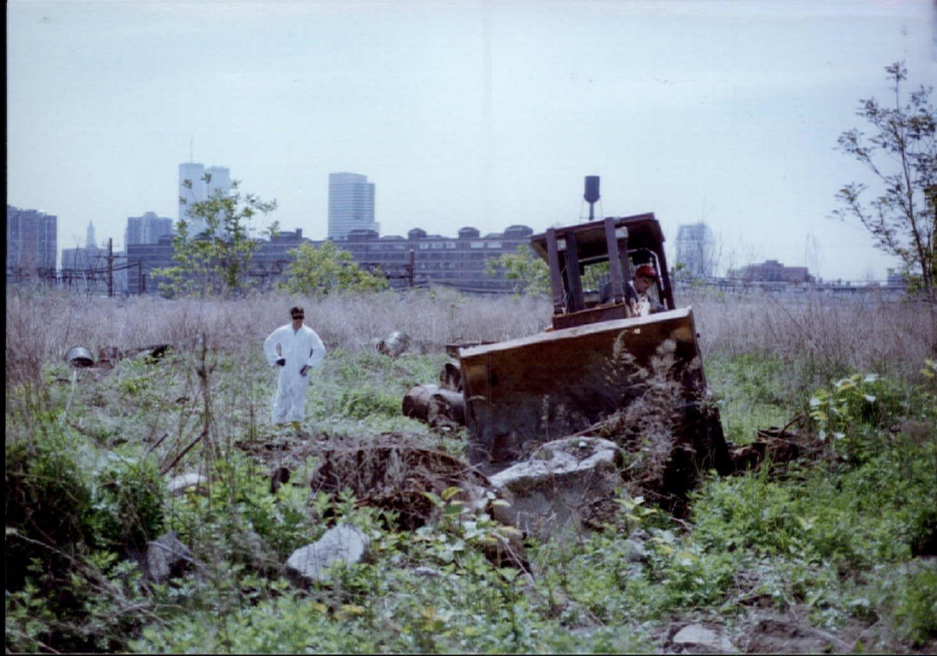
SITE: Ideal Cooperage, Jersey City, NJ
DATE: 05/08/91 PHOTO BY: P. Di Pasca
DESCRIPTION: Clearing of non-hazardous
debris with track loader

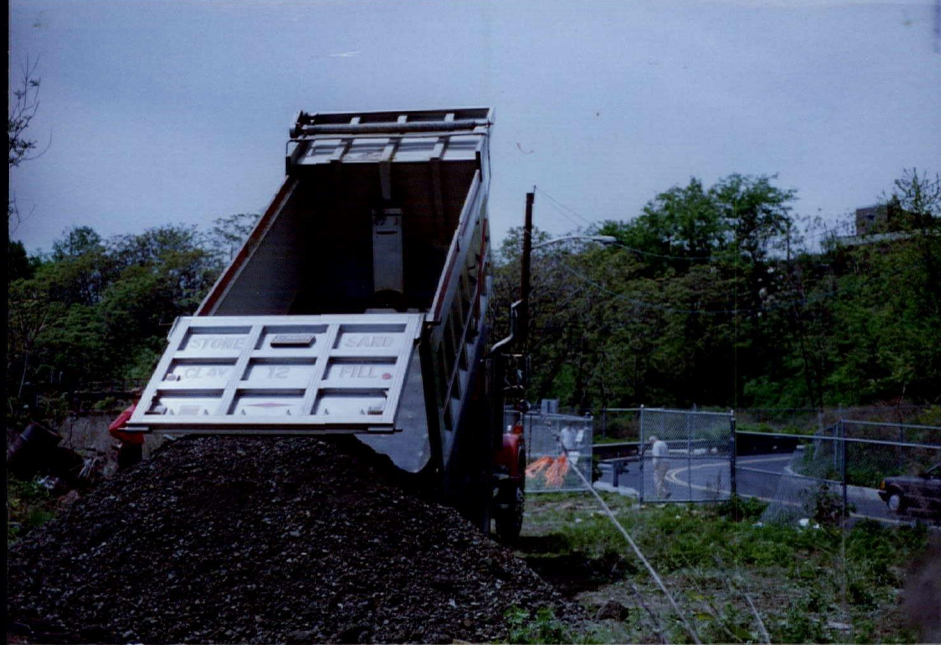
SITE: Ideal Cooperage, Jersey City, NJ
DATE: 05/08/91 PHOTO BY: P. Di Pasca
DESCRIPTION: Delivery of road stone for
entrance to site
(1st load)

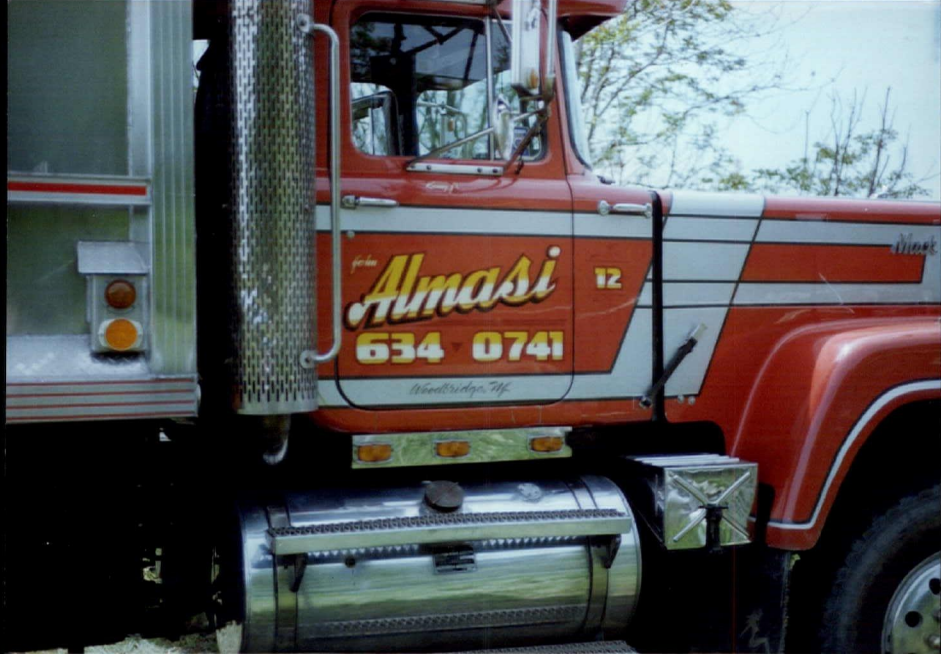
SITE: Ideal Cooperage, Jersey City, NJ
DATE: 05/08/91 PHOTO BY: P. Di Pasca
DESCRIPTION: Name, address and phone number
of road stone supplier

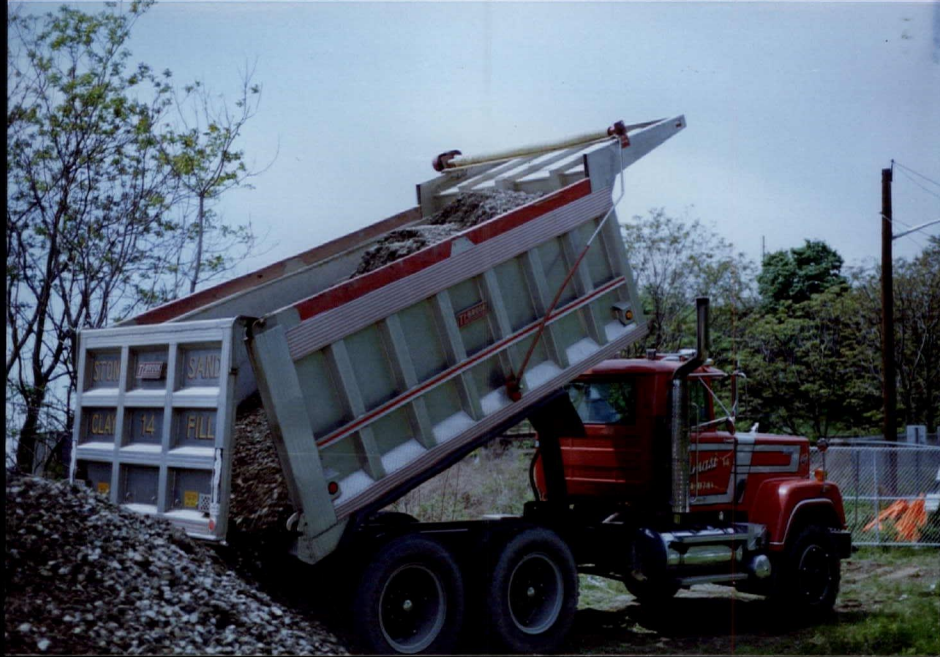
SITE: Ideal Cooperage, Jersey City, NJ
DATE: 05/08/91 PHOTO BY: P. Di Pasca
DESCRIPTION: Delivery of road stone for
entrance to site
(2nd load)

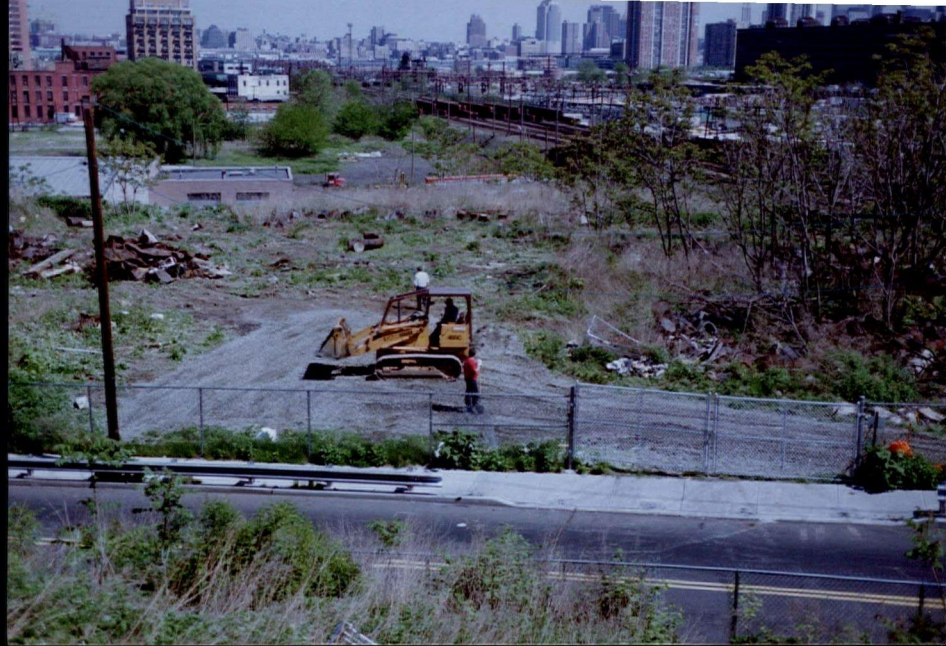
SITE: Ideal Cooperage, Jersey City, NJ
DATE: 05/08/91 PHOTO BY: P. Di Pasca
DESCRIPTION: Spreading of road stone
with track loader

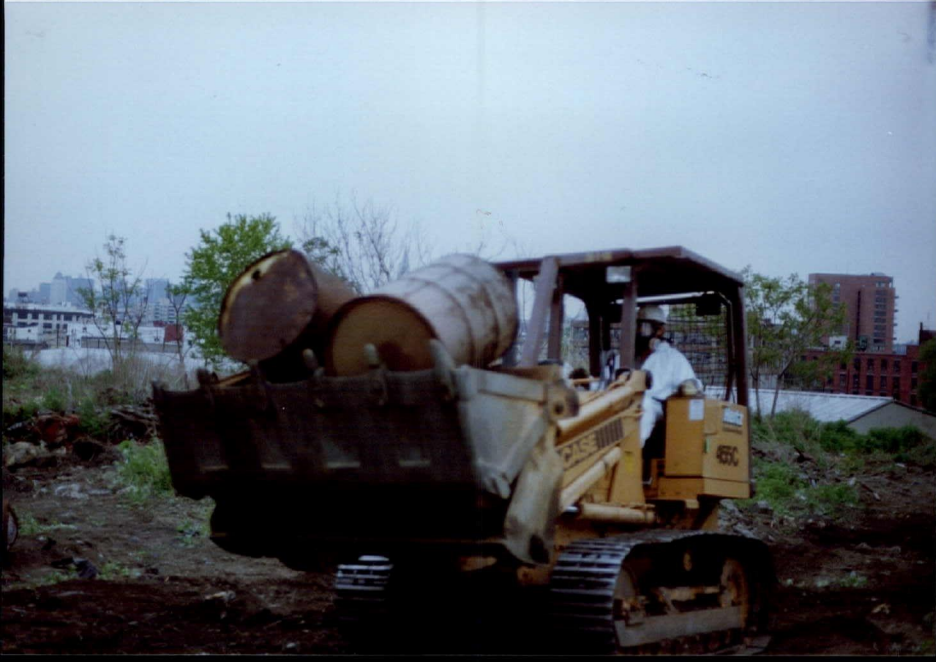
SITE: Ideal Cooperage, Jersey City, NJ
DATE: 05/08/91 PHOTO BY: P. Di Pasca
DESCRIPTION: Restaging of empty drums
with track loader

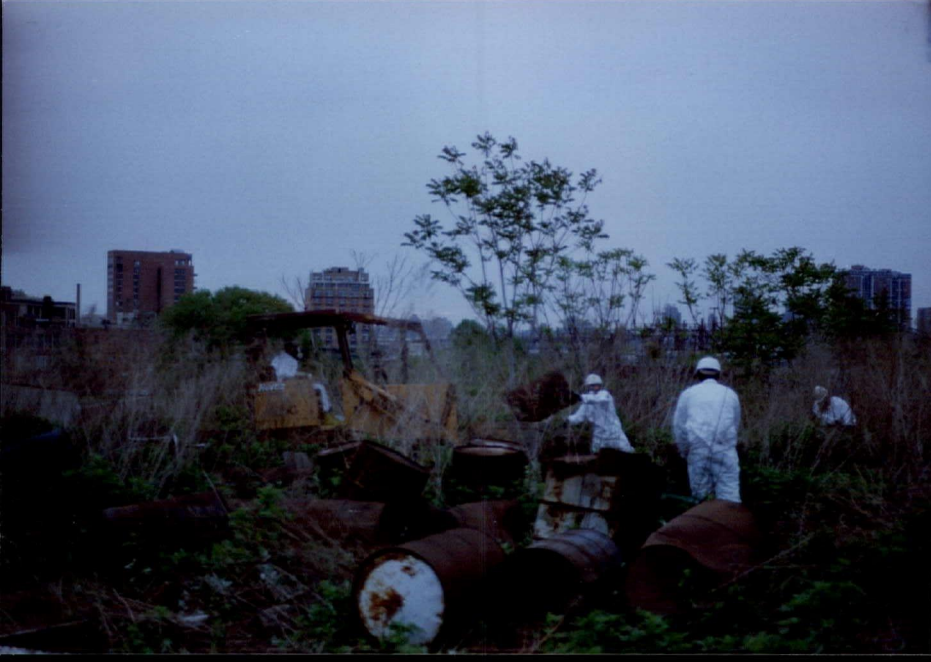
SITE: Ideal Cooperage, Jersey City, NJ
DATE: 05/08/91 PHOTO BY: P. Di Pasca
DESCRIPTION: Restaging of empty drums
with track loader

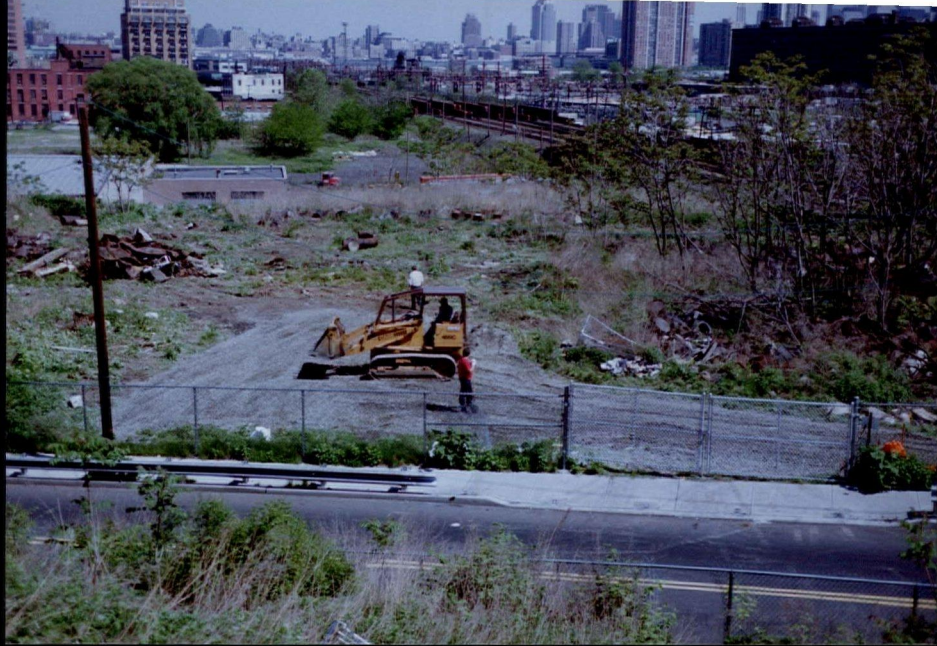
SITE: Ideal Cooperage, Jersey City, NJ
DATE: 05/08/91 PHOTO BY: P. Di Pasca
DESCRIPTION: Spreading of road stone
with track loader

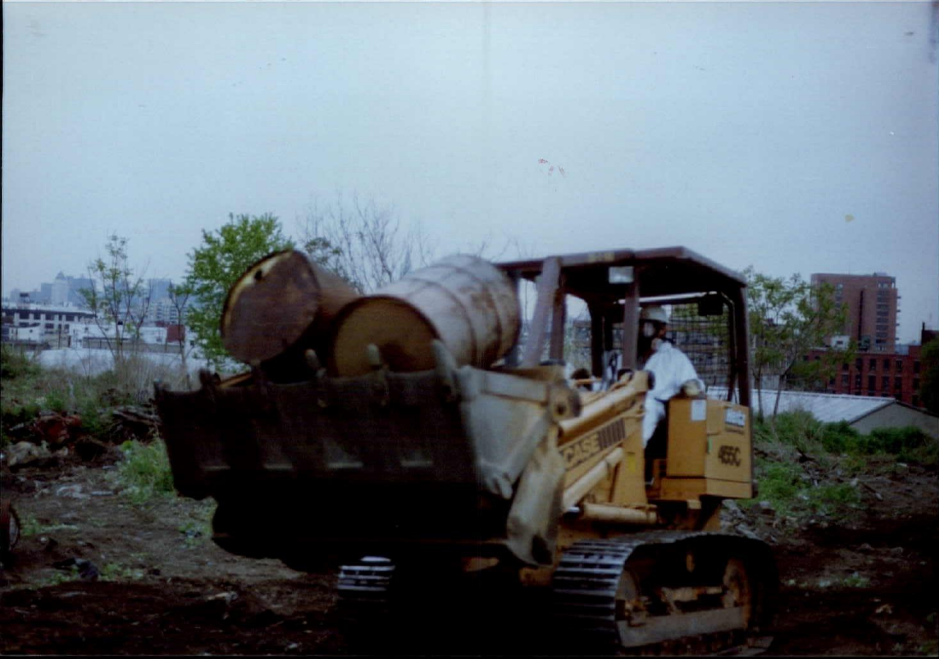
SITE: Ideal Cooperage, Jersey City, NJ
DATE: 05/08/91 PHOTO BY: P. Di Pasca
DESCRIPTION: Restaging of empty drums
with track loader

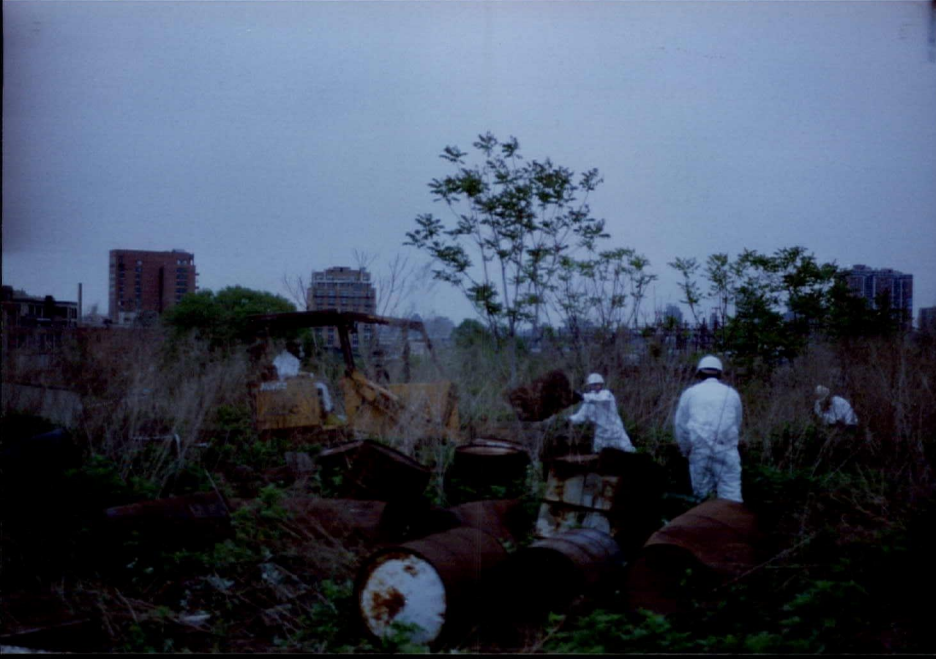
SITE: Ideal Cooperage, Jersey City, NJ
DATE: 05/08/91 PHOTO BY: P. Di Pasca
DESCRIPTION: Restaging of empty drums
with track loader
